**HUMMING GARDENS - VILLAS COMPLETION STATUS**

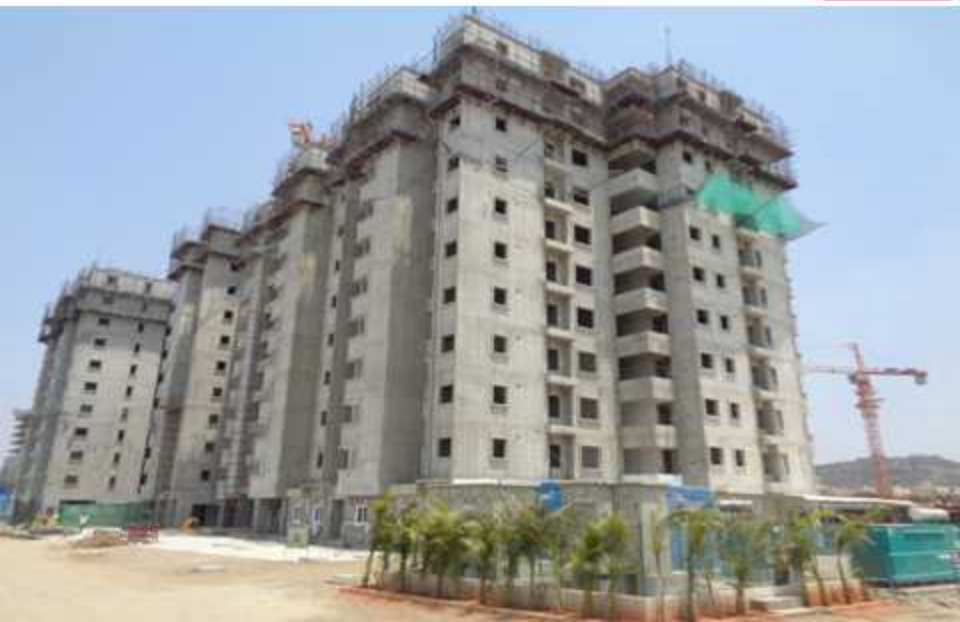
**Block 2 (Claudius - A)-10th Floor Wall & Slab Completed.**  
View from Southeast Corner.

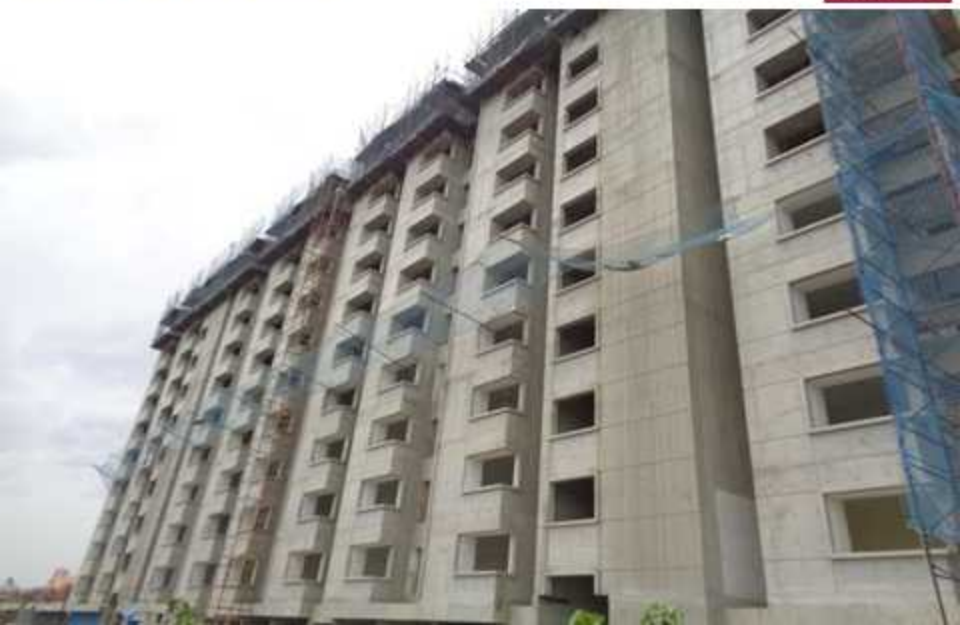
**Block 3 Part - 1 (Magnus - B) -10th Floor Wall & Slab in Progress.**  
View from Southwest Corner.

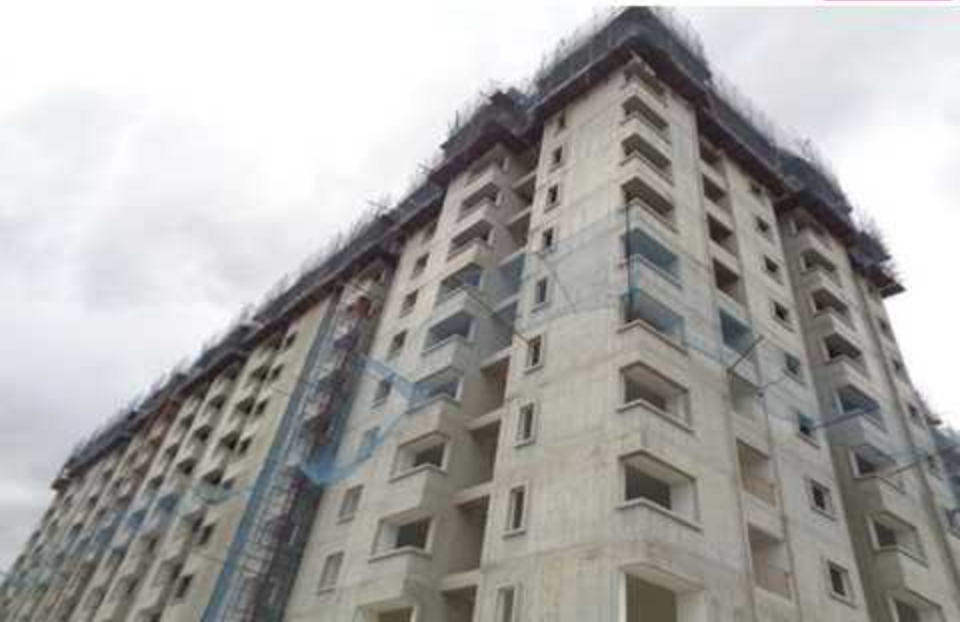
**Block 3 Part - 1 (Magnus - A) - 10th Floor Wall & Slab in Progress.**  
View from Southwest Corner.

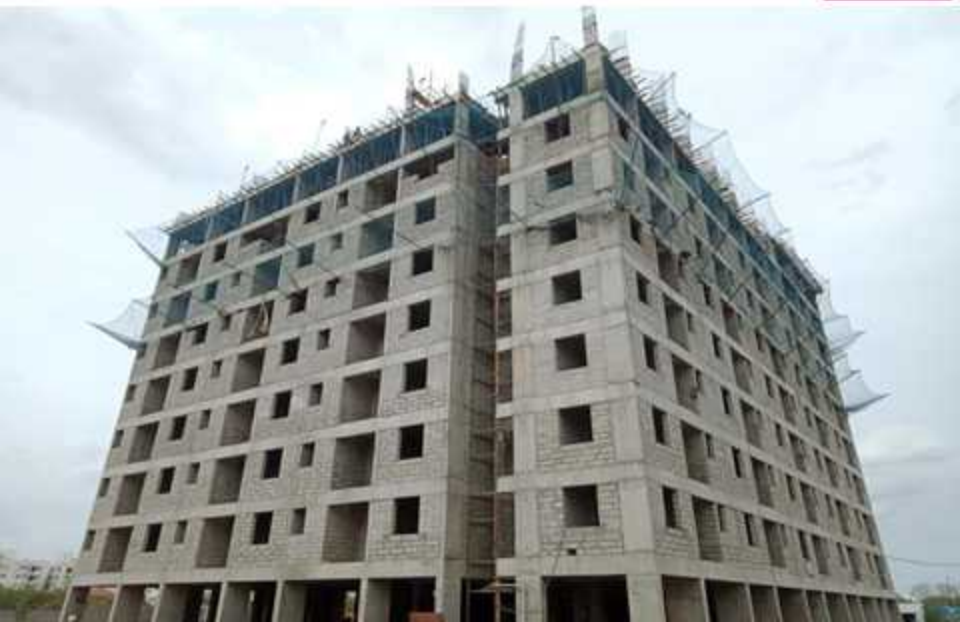
**Block 6 (Agustus) – 9th Floor Column & 10th Floor Slab in Progress.**  
View from Southwest Corner.

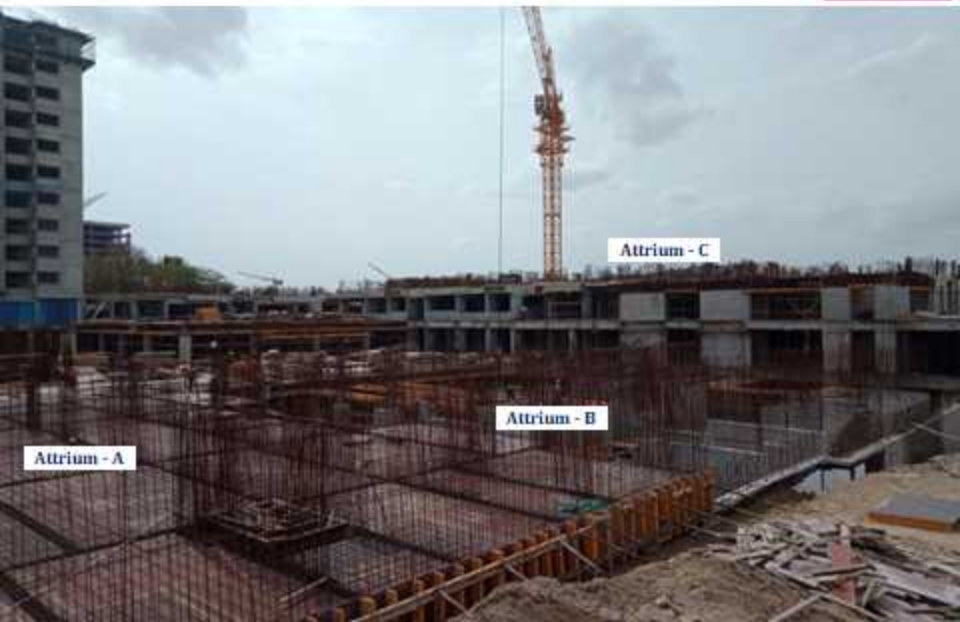
**Block 5 Part - 2 (Atrium - B) – UB Floor Slab in Progress. View from Southeast Corner.**

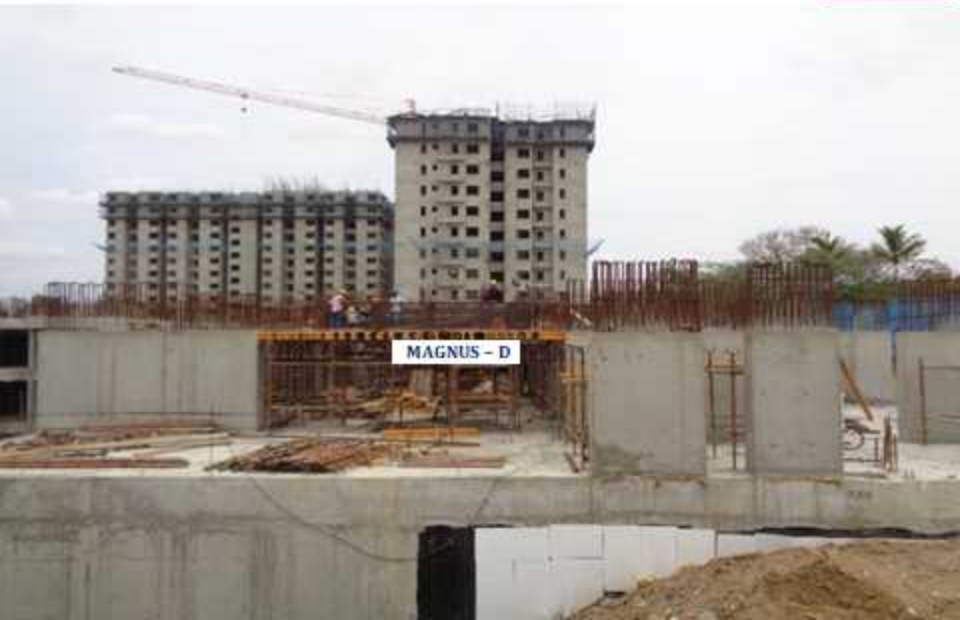
**Block 3 Part - 2 (Magnus - D) - 1<sup>st</sup> Floor Slab with Girder Beam  
Completed & Balance in Progress. View from North.**

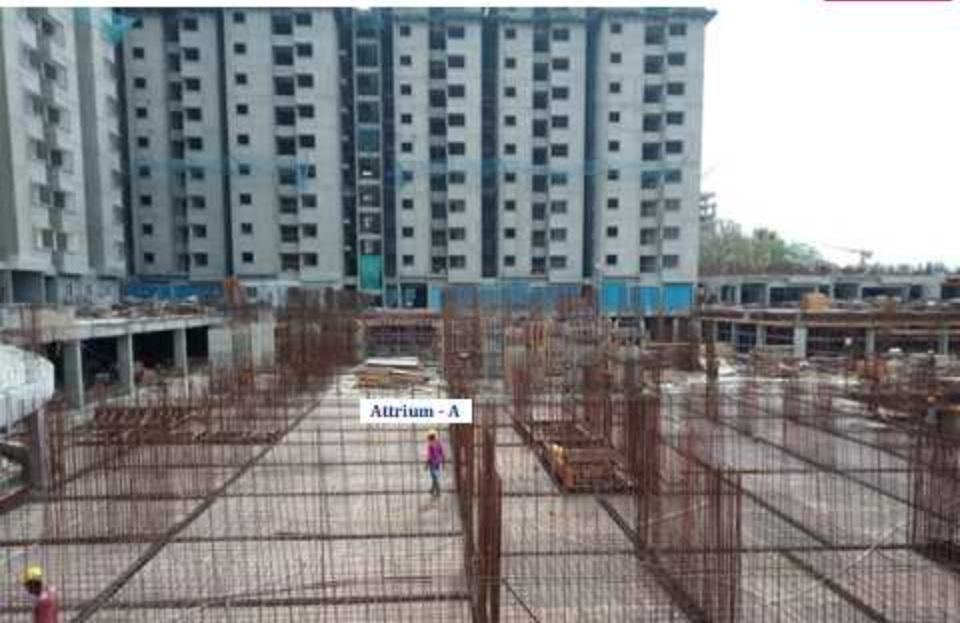
**Block 5 Part - 3 (Atrium - A) - 60% of Upper Basement Floor Slab Completed & Balance in Progress. View from East.**

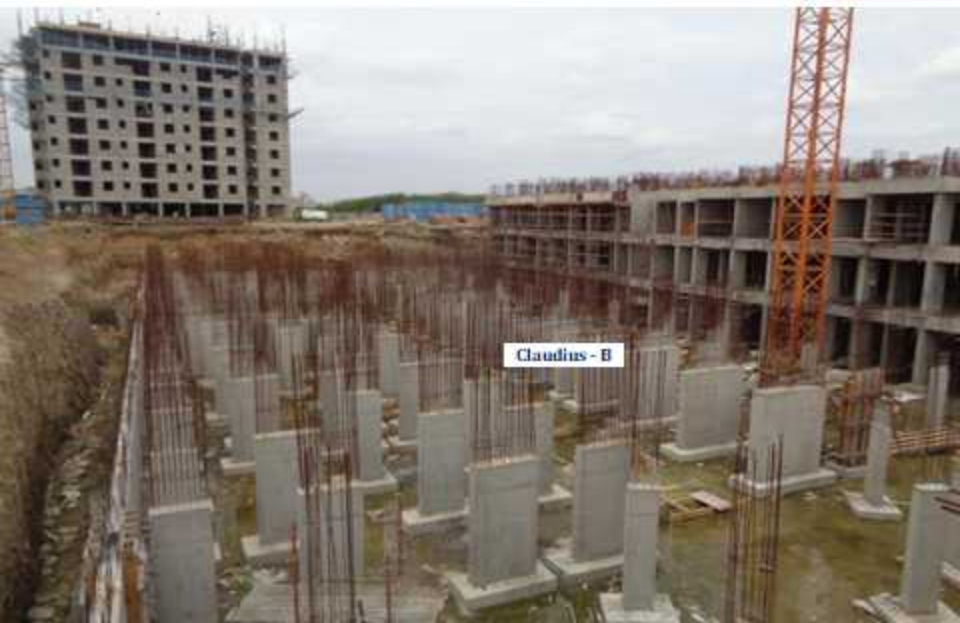
Claudius - B

**Block 4 (Claudius - B) - Lower Basement - Retaining Wall Completed & 90% of Column Completed. View from West.**

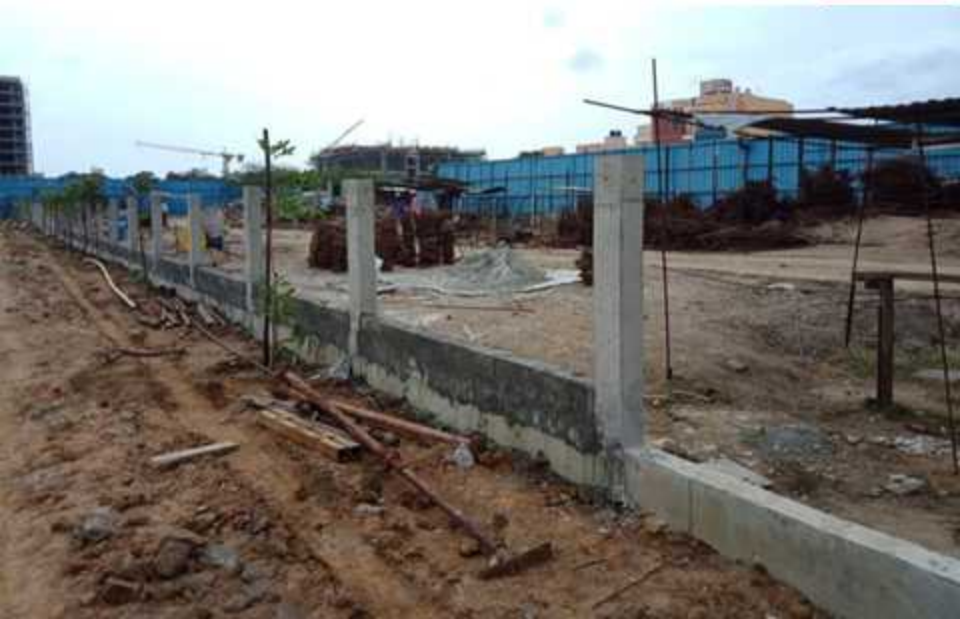
**Compound Wall – OSR South Side Compound Wall in Progress.  
View from Southeast Corner.**

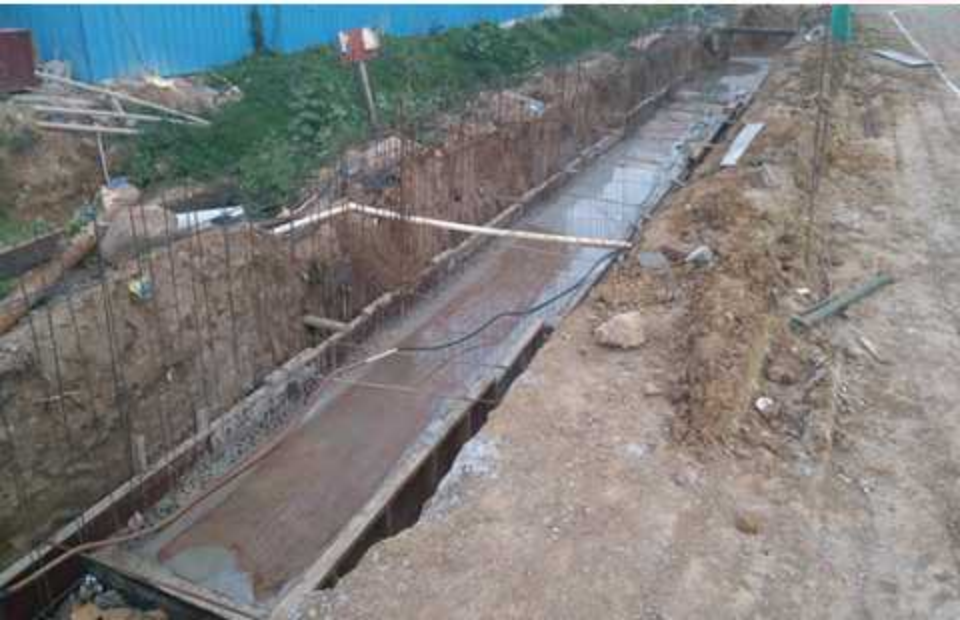
**Compound Wall – Block 2 East Side Compound Wall in Progress.  
View from Northwest Corner.**

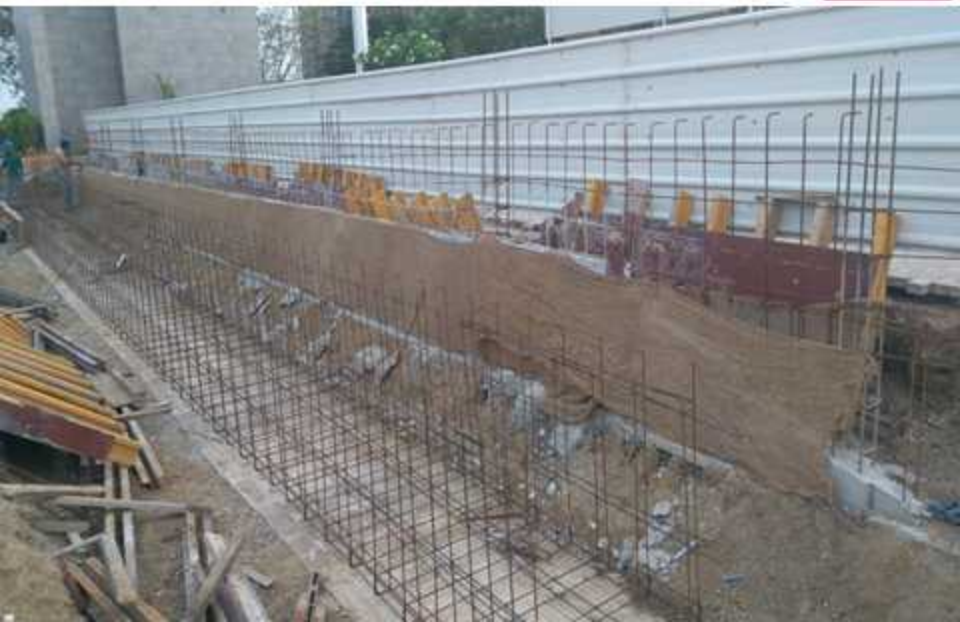
**Compound Wall – 18m Road West Side Compound Wall & Cable Trench in Progress. View from Northeast Corner.**

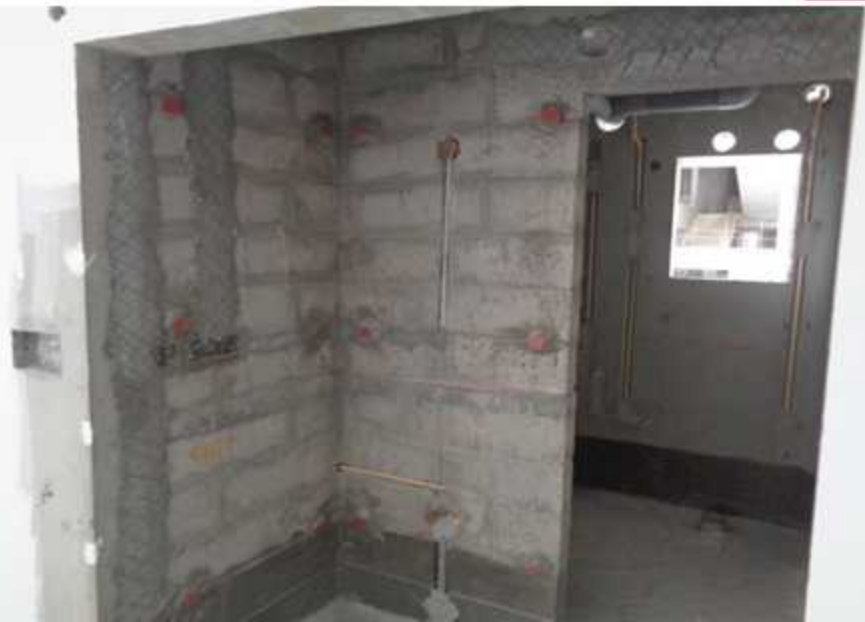
**Block 2 (Claudius - A)-** Block Work Completed up to 9<sup>th</sup> Floor &  
Plastering Completed up to 3<sup>rd</sup> Floor.

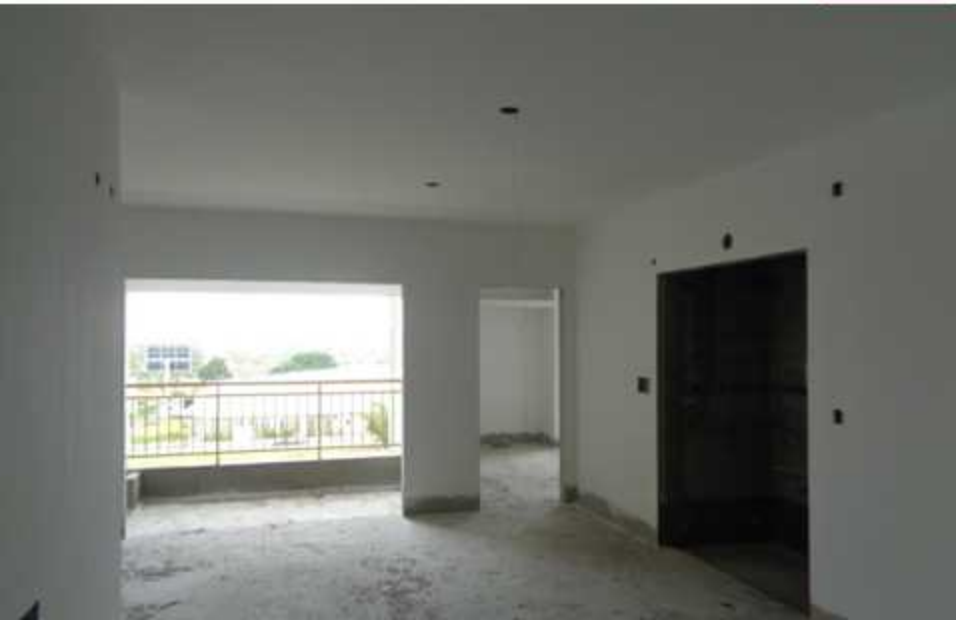
**Block 2 (Claudius - A)- Internal Wall Putty Completed up to 5<sup>th</sup> Floor  
& in Progress at 6<sup>th</sup> Floor.**

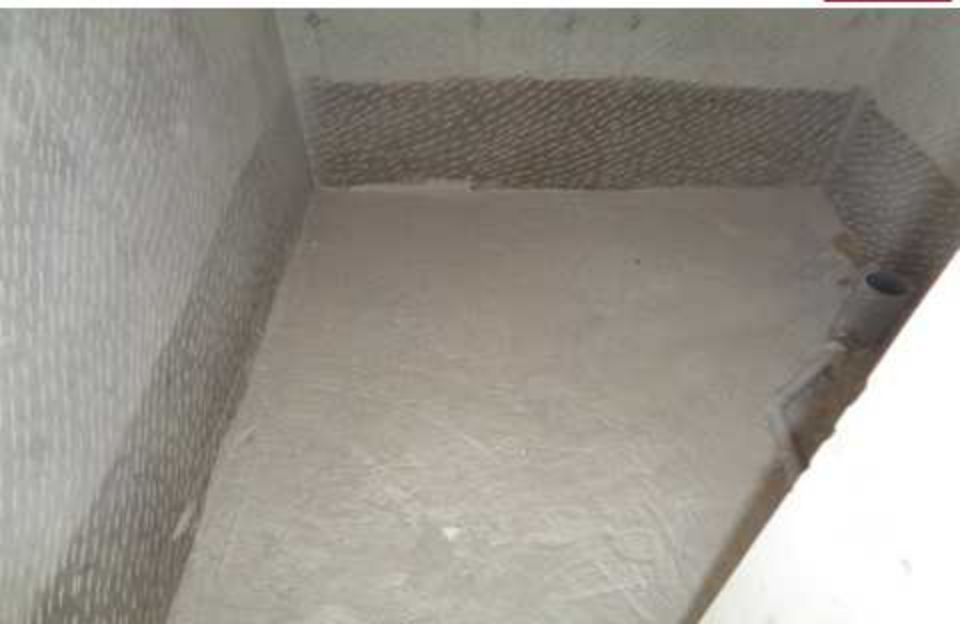
**Block 2 (Claudius - A)- Waterproofing work Completed up to 5<sup>th</sup> Floor.**

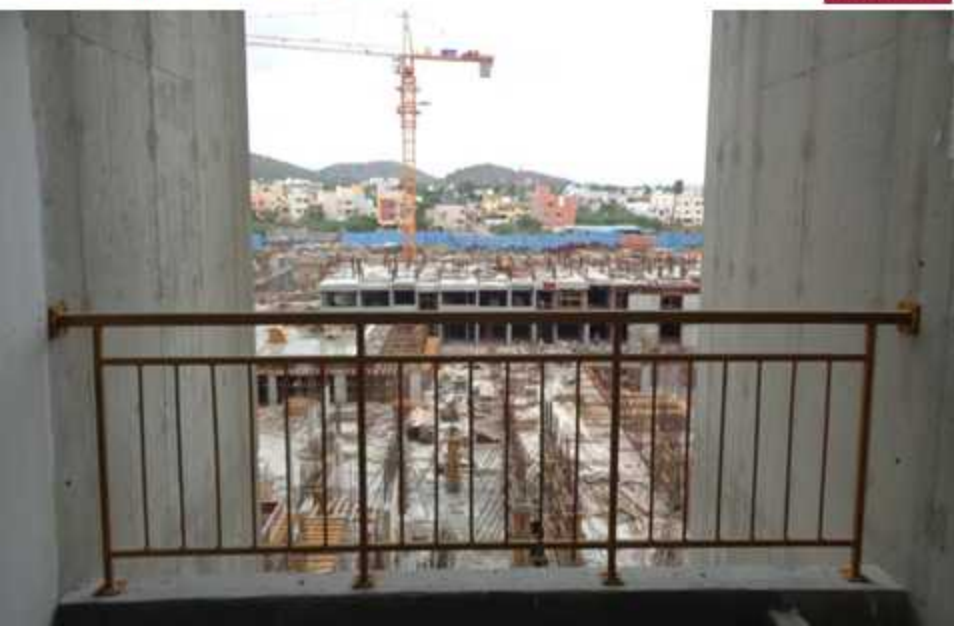
**Block 2 (Claudius - A)- Balcony Handrail Fixing Completed Up to 4<sup>th</sup> Floor and in Progress at 5<sup>th</sup> Floor.**

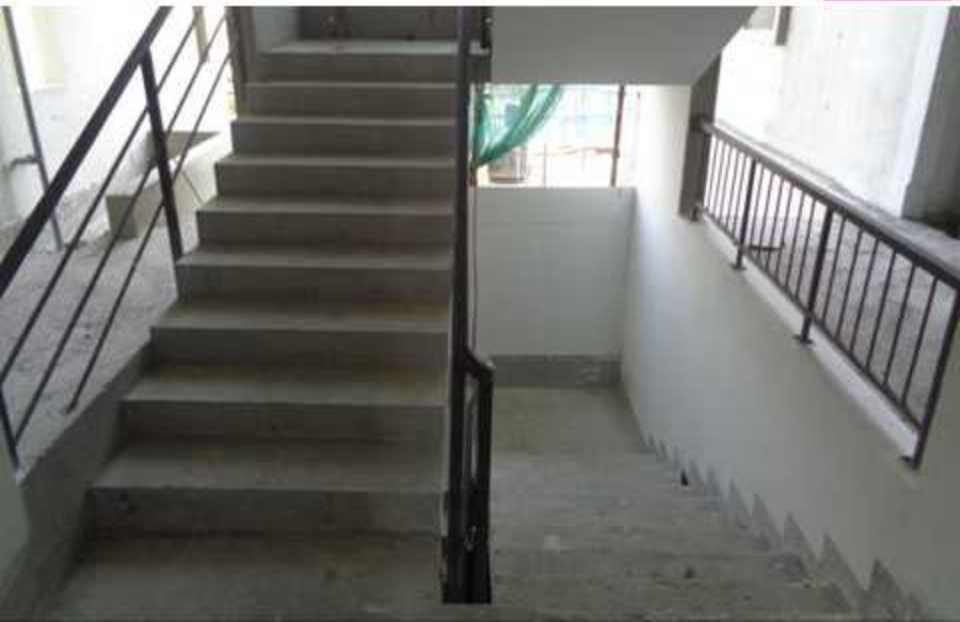
**Block 2 (Claudius - A)- Fire Escape Staircase Handrail Fixing**  
Completed up to 2<sup>nd</sup> floor and in progress at 3<sup>rd</sup> floor.

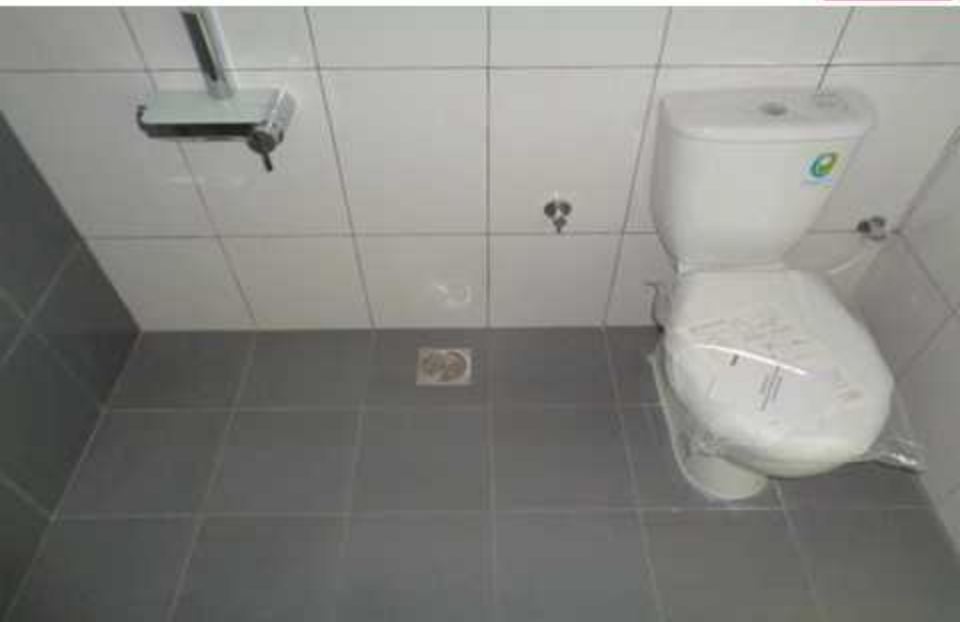
**Block 2 (Claudius - A)- Common Toilet Floor Tile, CP & Sanitary Fittings in Progress at 1<sup>st</sup> Floor.**

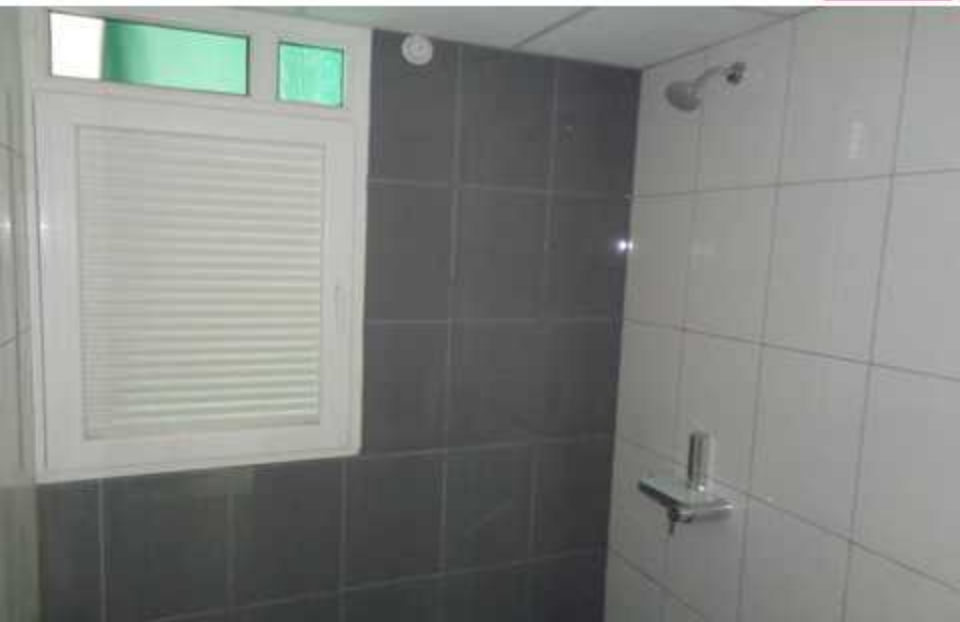
**Block 2 (Claudius - A)- Common Toilet Wall Tile in Progress at 1<sup>st</sup> Floor.**

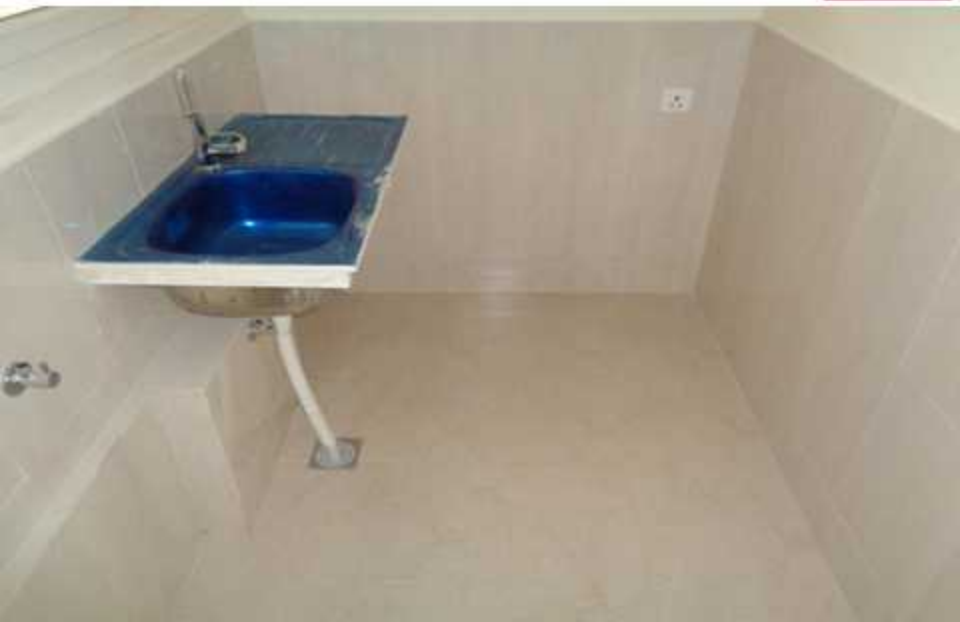
**Block 2 (Claudius - A)- Service Area Wall & Floor Tile Completed at 1<sup>st</sup> Floor.**

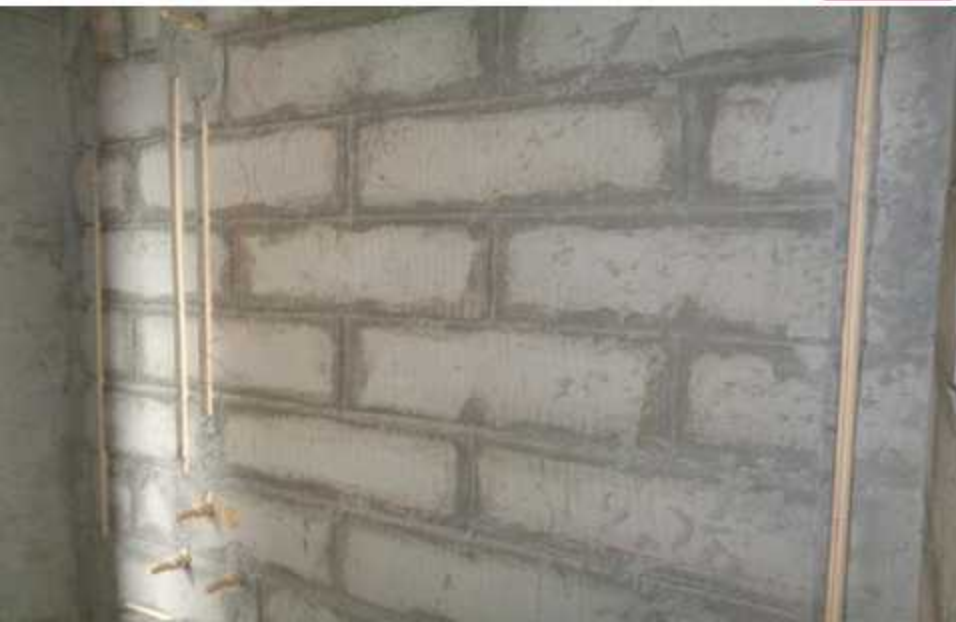
**Block 3/1 – (Magnus - A & B) - Block Work Completed up to 8<sup>th</sup> Floor  
& Plastering Completed up to 2<sup>nd</sup> Floor.**

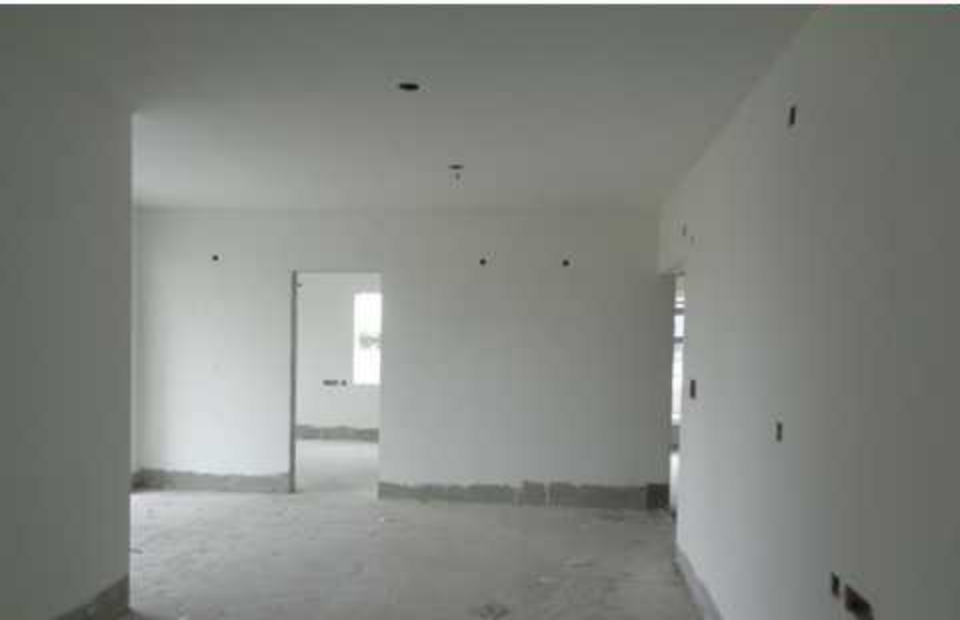
**Block 3/1 - (Magnus - A & B) - Internal Wall Putty Completed up to 3<sup>rd</sup> Floor and in Progress at 4<sup>th</sup> Floor.**

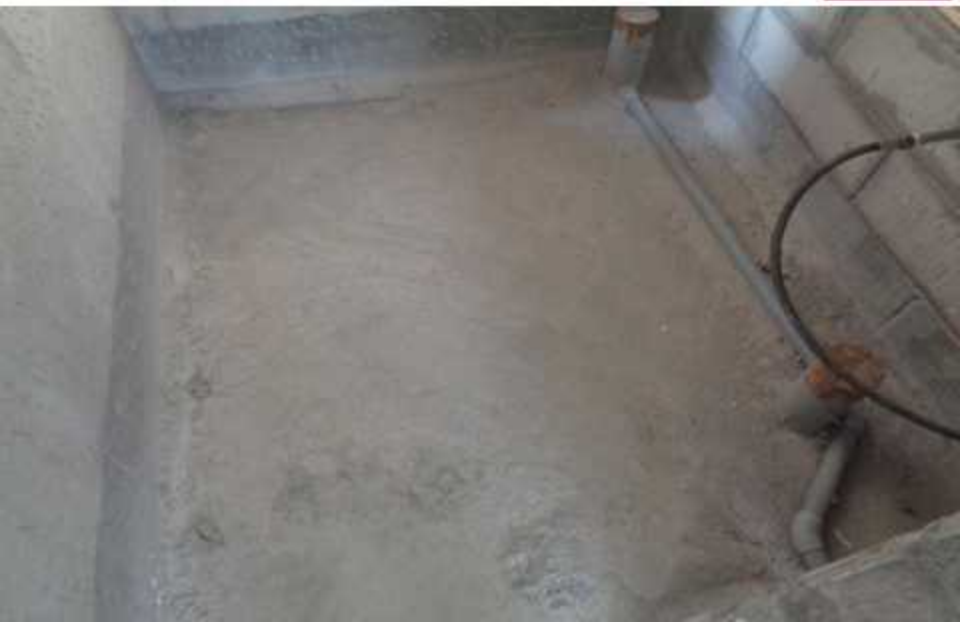
**Block 3/1 – (Magnus - A & B) - Waterproofing Completed up to 6<sup>th</sup>  
Floor.**

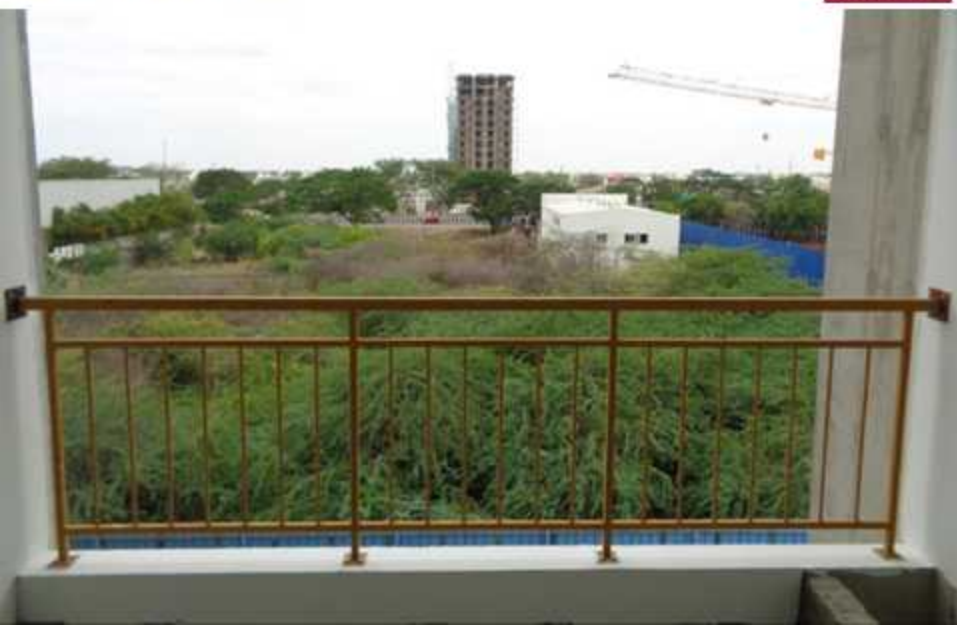
**Block 3/1 – (Magnus - A & B) - Balcony Handrail Fixing work in Progress up to 2<sup>nd</sup> Floor.**

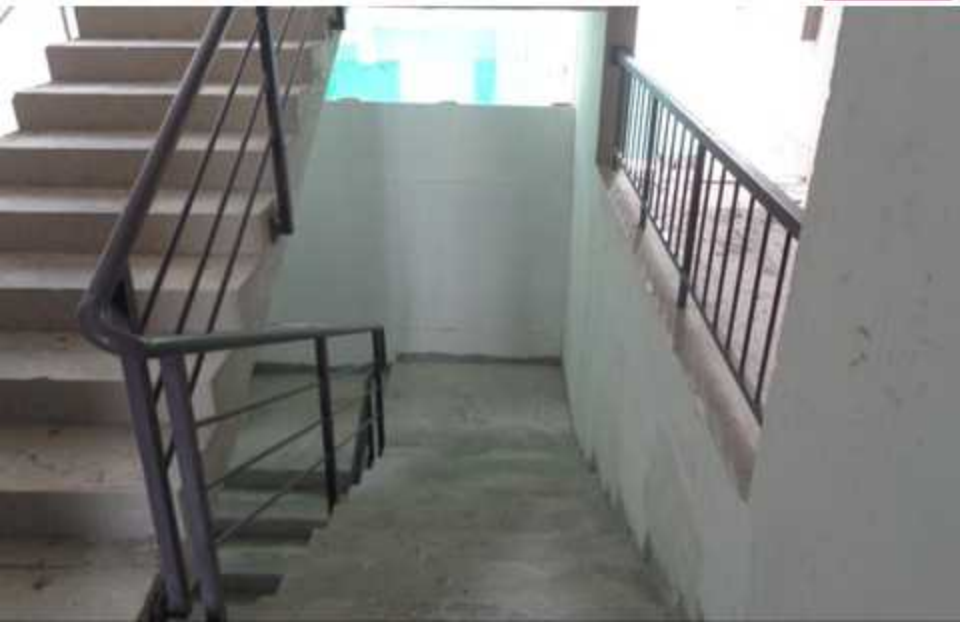
**Block 3/1 - (Magnus - A & B) - Staircase Handrail Fixing Completed up to 2<sup>nd</sup> floor and in progress at 3<sup>rd</sup> floor.**

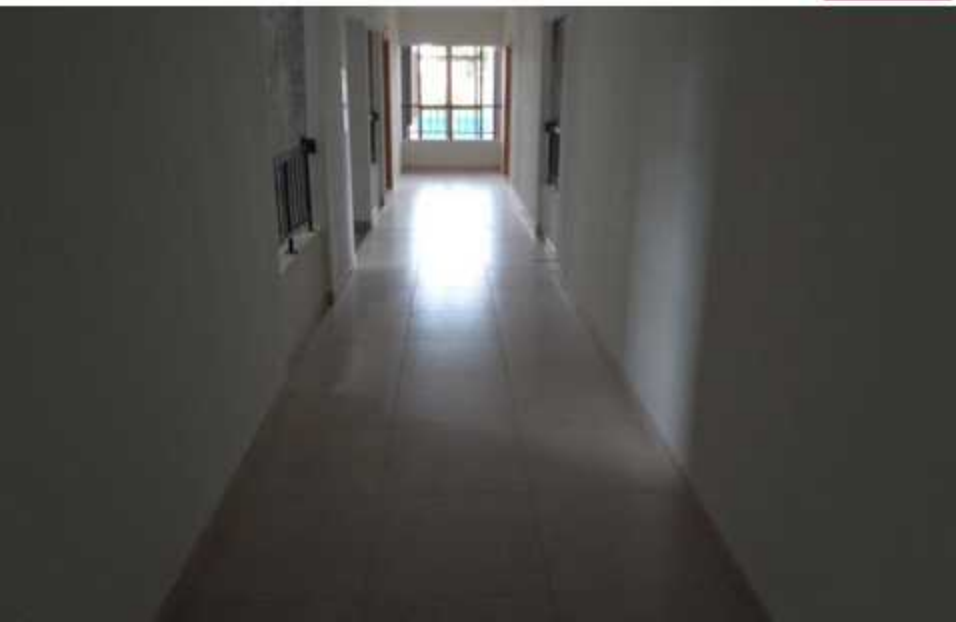
Block 3/1 – (Magnus - A & B) - Corridor Floor Tile in Progress at 1<sup>st</sup> Floor.

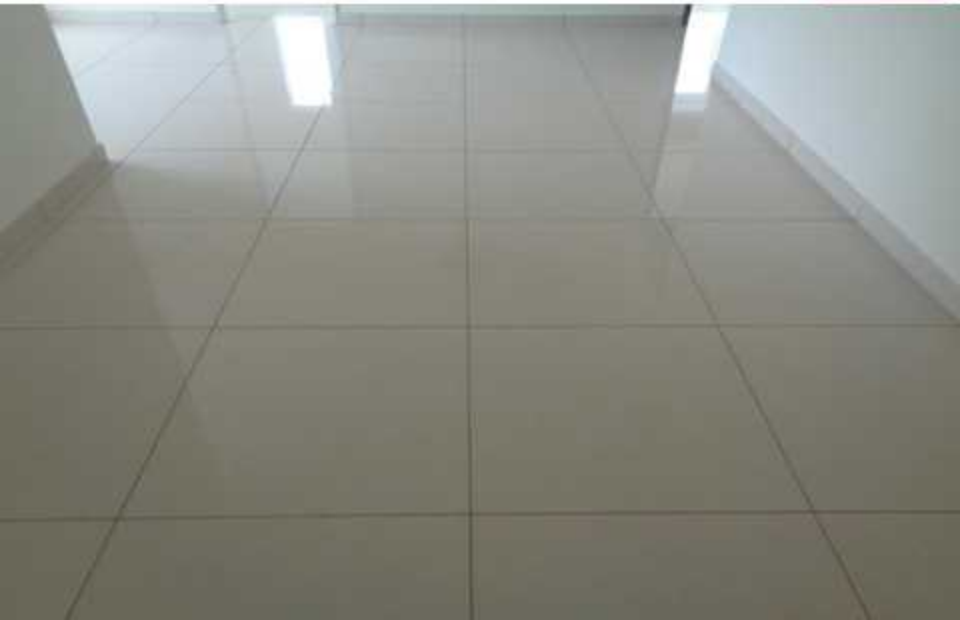
**Block 3/1 - (Magnus - A & B) - Unit Floor Tile in Progress at 1<sup>st</sup> Floor.**

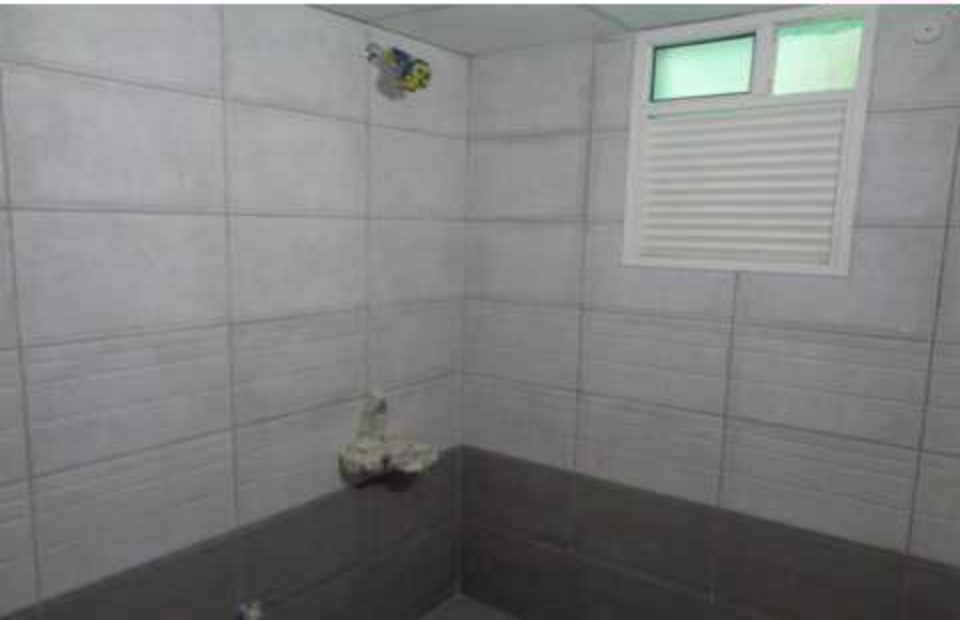
**Block 3/1 - (Magnus - A & B) - Master Bed Room Toilet Wall Tile in Progress at 1<sup>st</sup> Floor.**

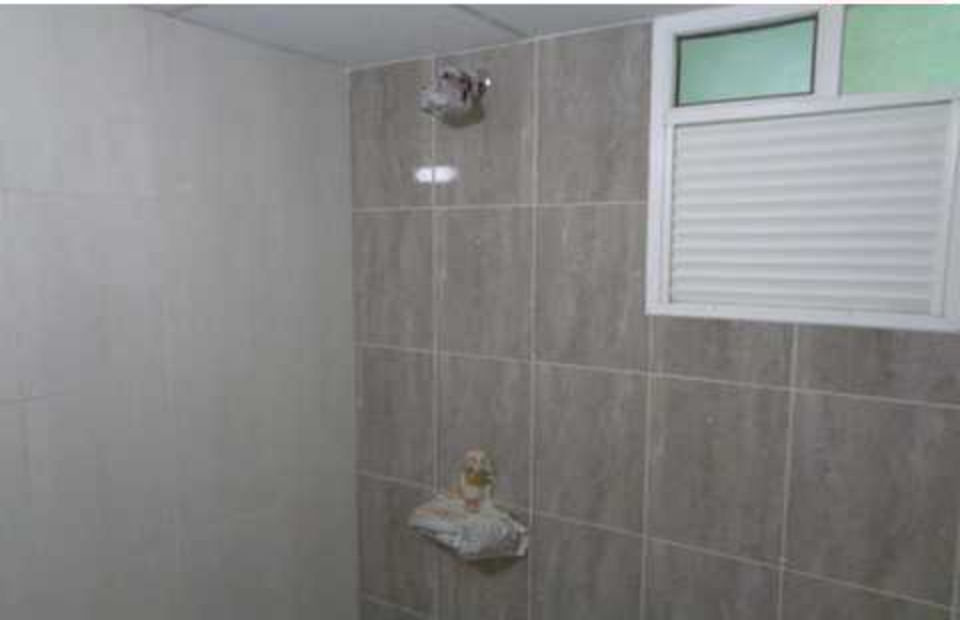
**Block 3/1 - (Magnus - A & B) - Attached Toilet Wall Tile in Progress  
at 1<sup>st</sup> Floor.**

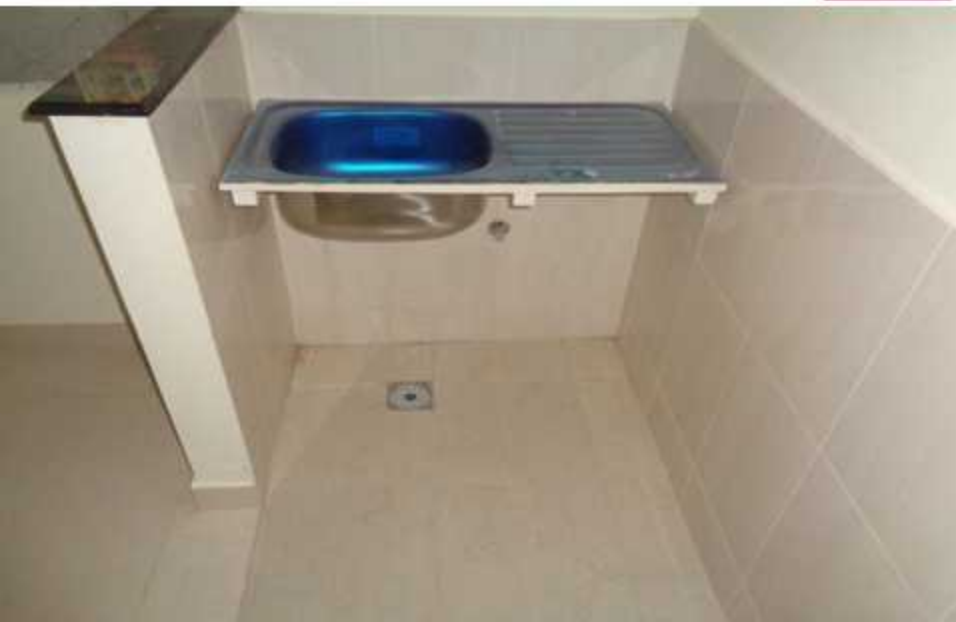
**Block 3/1 - (Magnus - A & B) - Service Area Wall & Floor Tile in Progress at 1<sup>st</sup> Floor.**

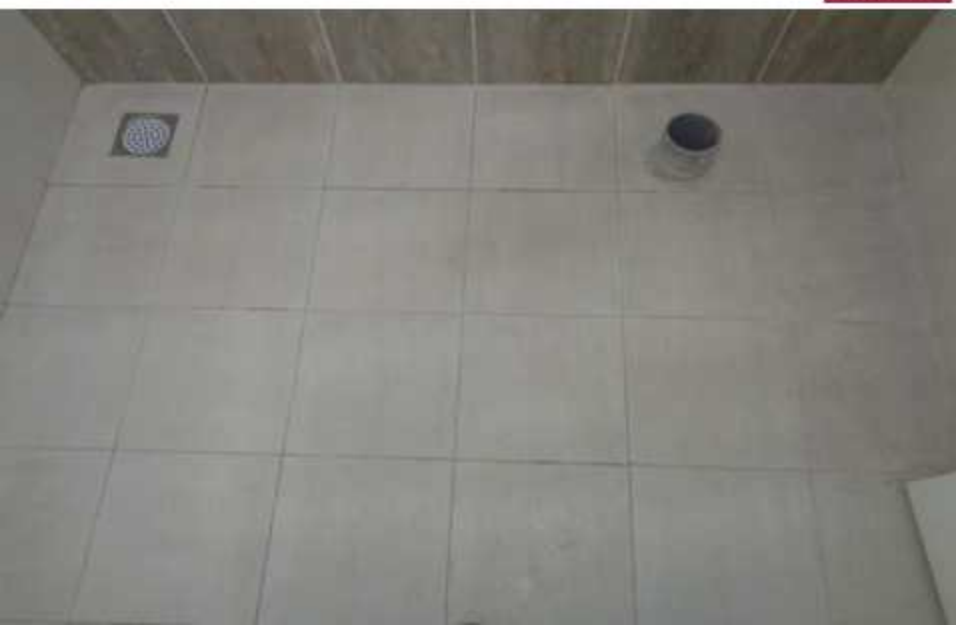
**Block 3/1 - (Magnus - A & B) - Attached Toilet Floor Tile in Progress  
at 1<sup>st</sup> Floor.**

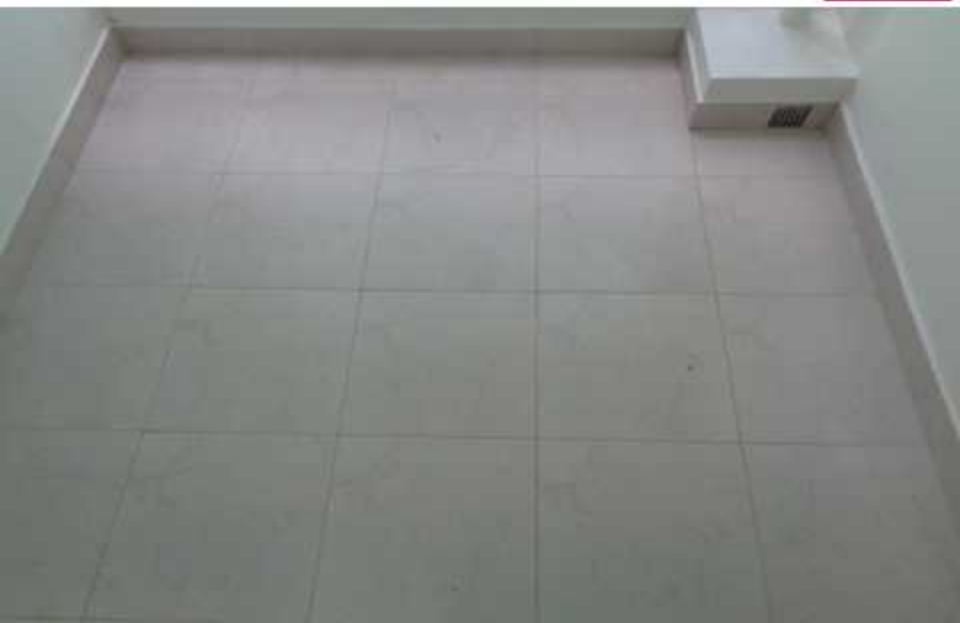
**Block 3/1 - (Magnus - A & B) - Balcony Floor Tile in Progress at 1<sup>st</sup> Floor.**

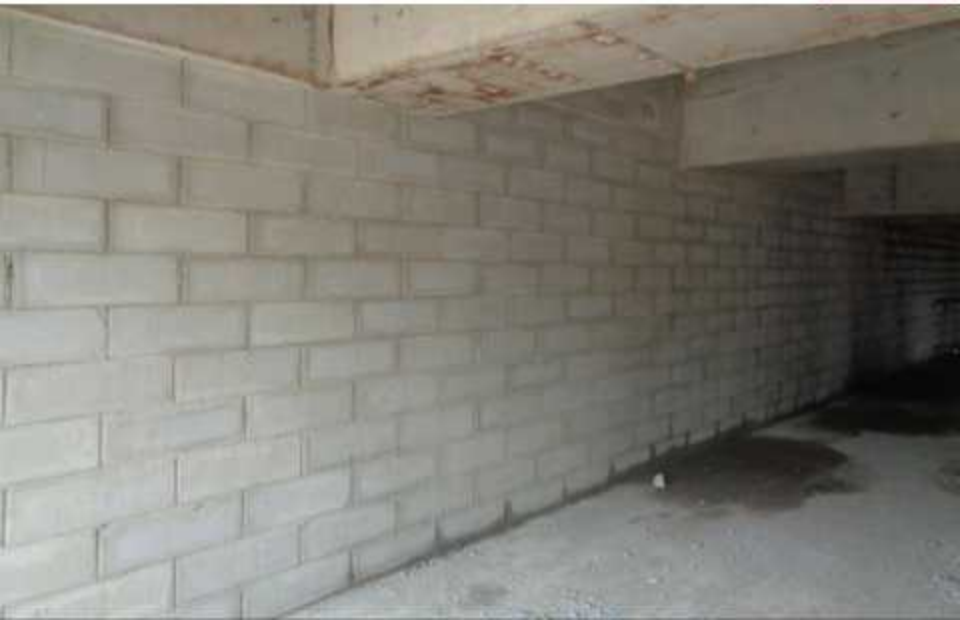
**Block 5 Part 1 - Stilt Floor - Grocery Shop Block Work in Progress.**  
View from Southwest Corner.
